## **Reclamation of Abandoned Coal Gob Piles and Stream Restoration in Yankee Canyon, Raton, New Mexico**

John A. Kretzmann, P.E.

New Mexico Abandoned Mine Land Program

April 2014

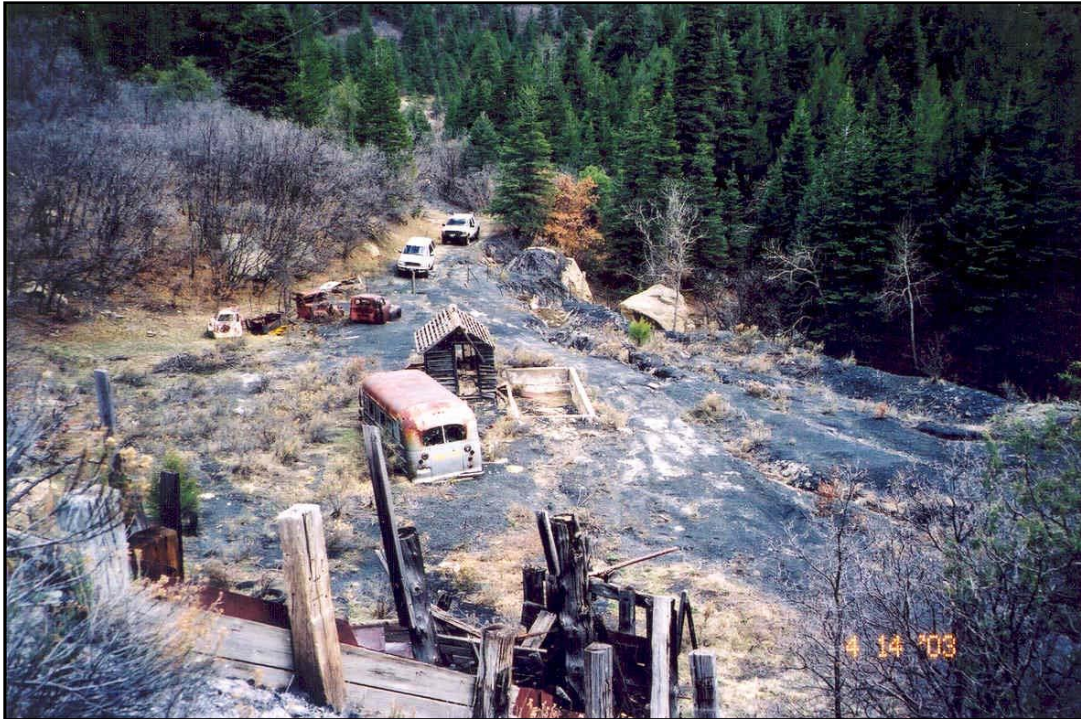
Sonchar Mine, April 2003. Note the timber loadout in the foreground.  
Abandoned vehicles were removed and recycled.

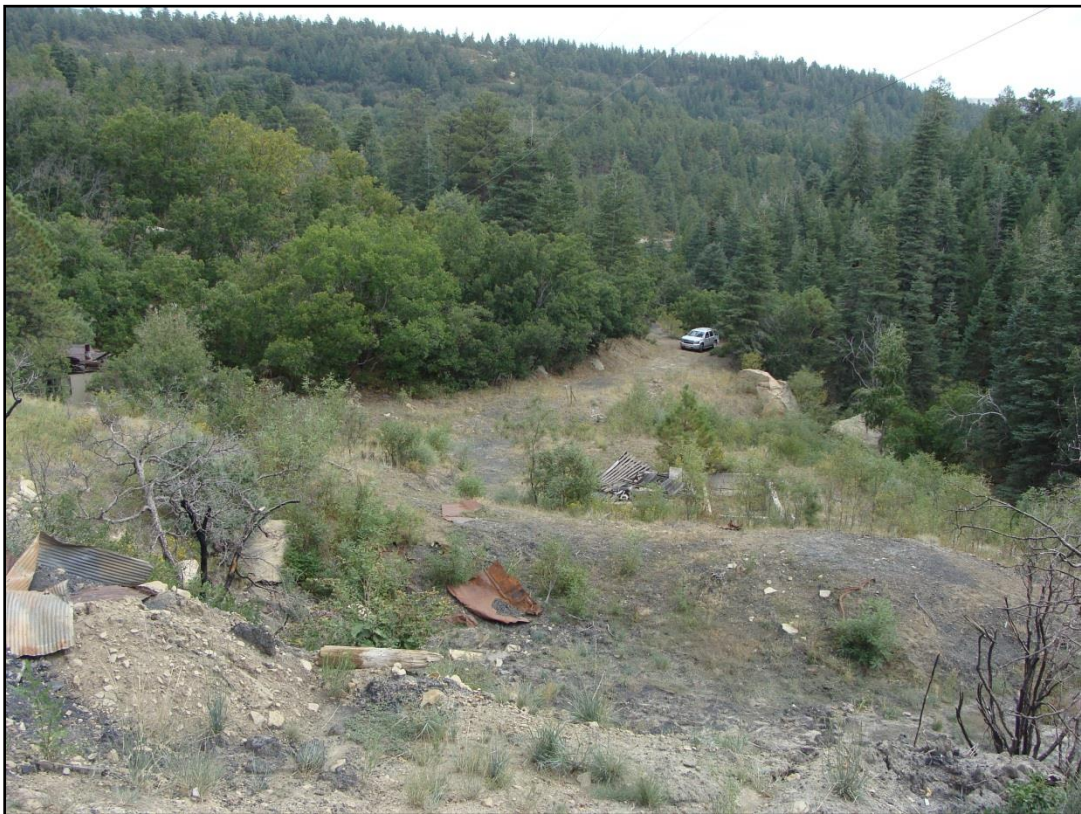
In 2013 and 2014, the third maintenance project is underway to address impacts of the June 2011 Track Wildfire that burned across one edge of the reclamation site at the Sonchar Mine. This wildfire ignited a few rows of coir rolls and straw bales placed several years before, killing almost all of the seedlings planted along them. A gob fire was also kindled by the wildfire and extinguished in fall 2013.

Sonchar Mine after a wildfire burned the timber loadout and area in foreground, Sept. 2012

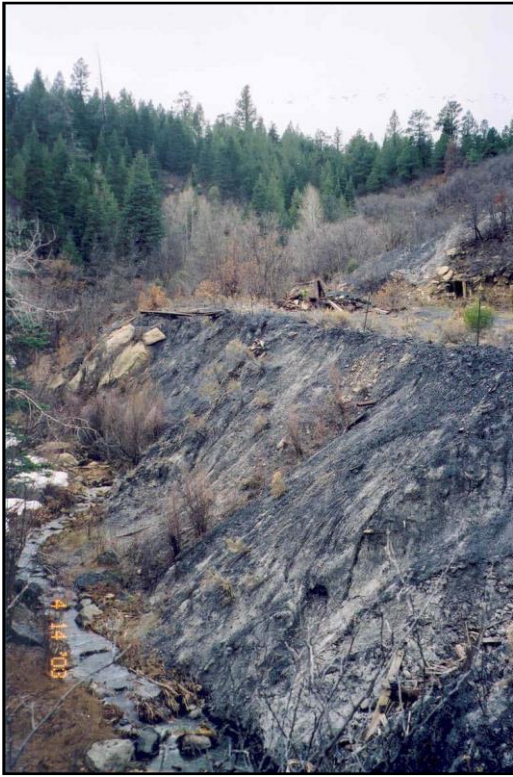
Sonchar Mine site and intermittent stream,  
April 2003

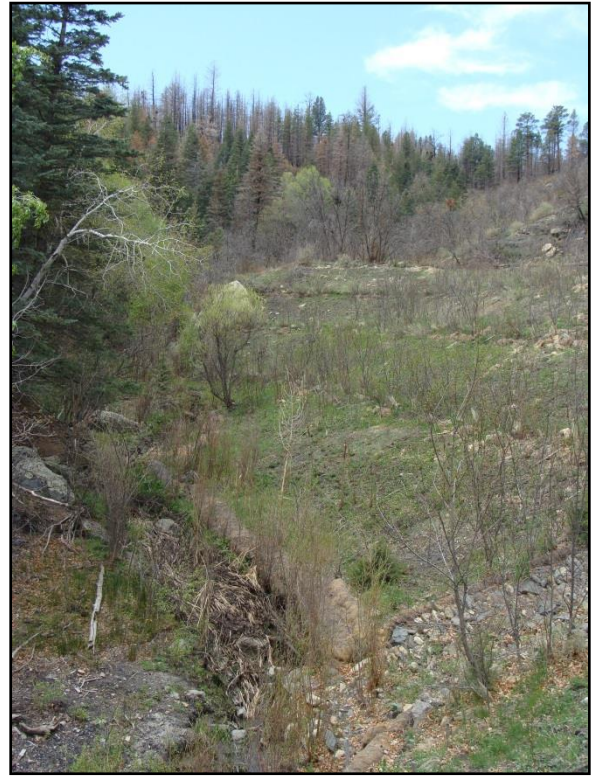
Sonchar Mine site, May 2013. Some impacts  
of the 2011 wildfire are visible in background.

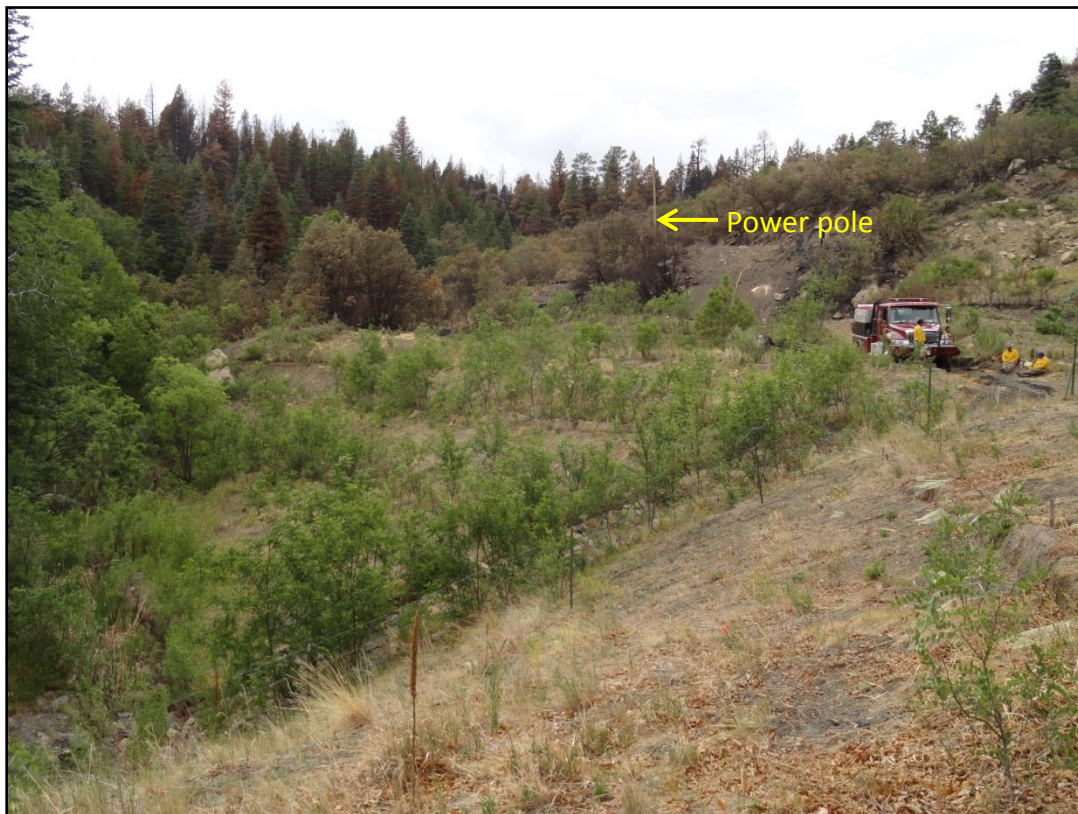
Sonchar Mine site immediately following the wildfire that burned across the northwest  
edge of the site, June 2011. A gob fire was ignited a few feet left of the power pole.

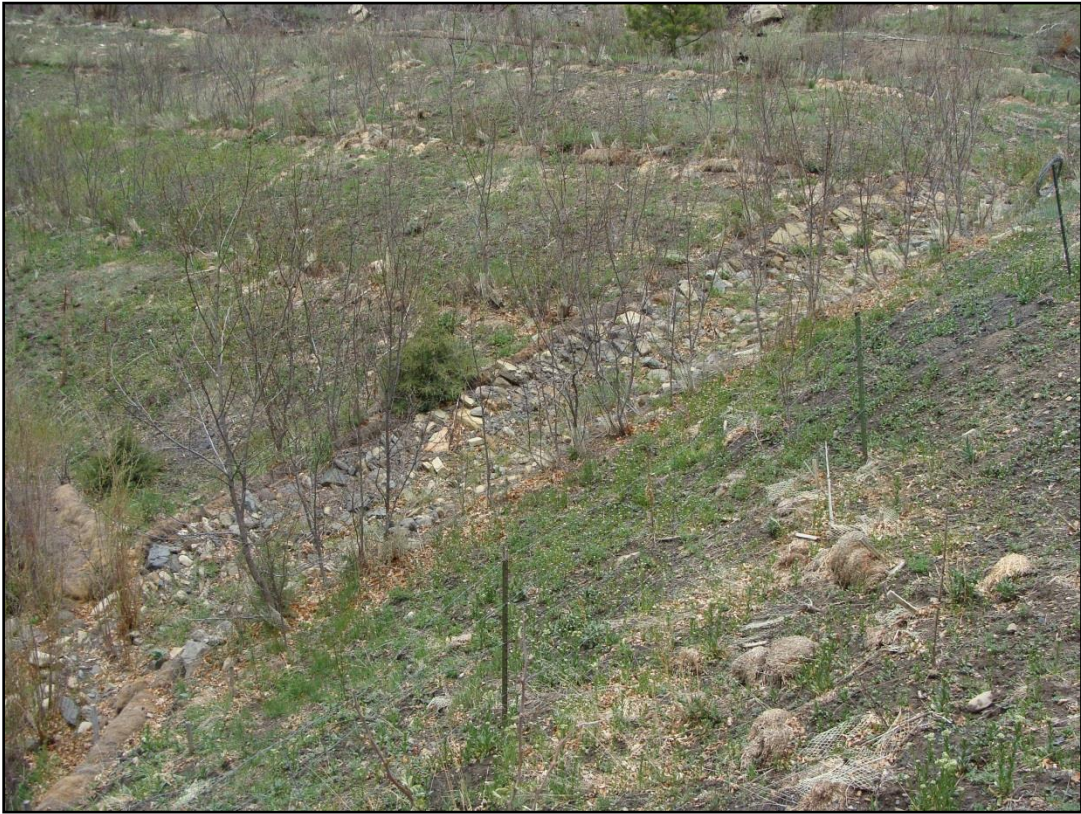
Rough-bed rock rundown at the Sonchar Mine site, May 2013. The trees planted along the rundown for root reinforcement and washout protection are just beginning to leaf out.

A rock rundown, based on “rough-bed channel” design guidelines developed by H. Lorenz and the Department of Technology at the University of Munich in the 1950s (and used primarily for water channeling on German autobahns) (Schiechtl, 1980, pp. 16-17) was constructed to carry storm flows across the reclamation site. The channel is designed to be elastic and consists of rock properly sized for the design flow (in this case the 100-year, 24-hour storm) placed by hand onto a permeable bed of coarse sand and fine gravel with the joints in the rock filled with crushed gravel. The rundown was initially reinforced for flow shear resistance with several rows of juniper posts driven across the rock channel. Longer term channel reinforcement and protection from washout is provided by the roots of small trees planted along both sides of the rundown.

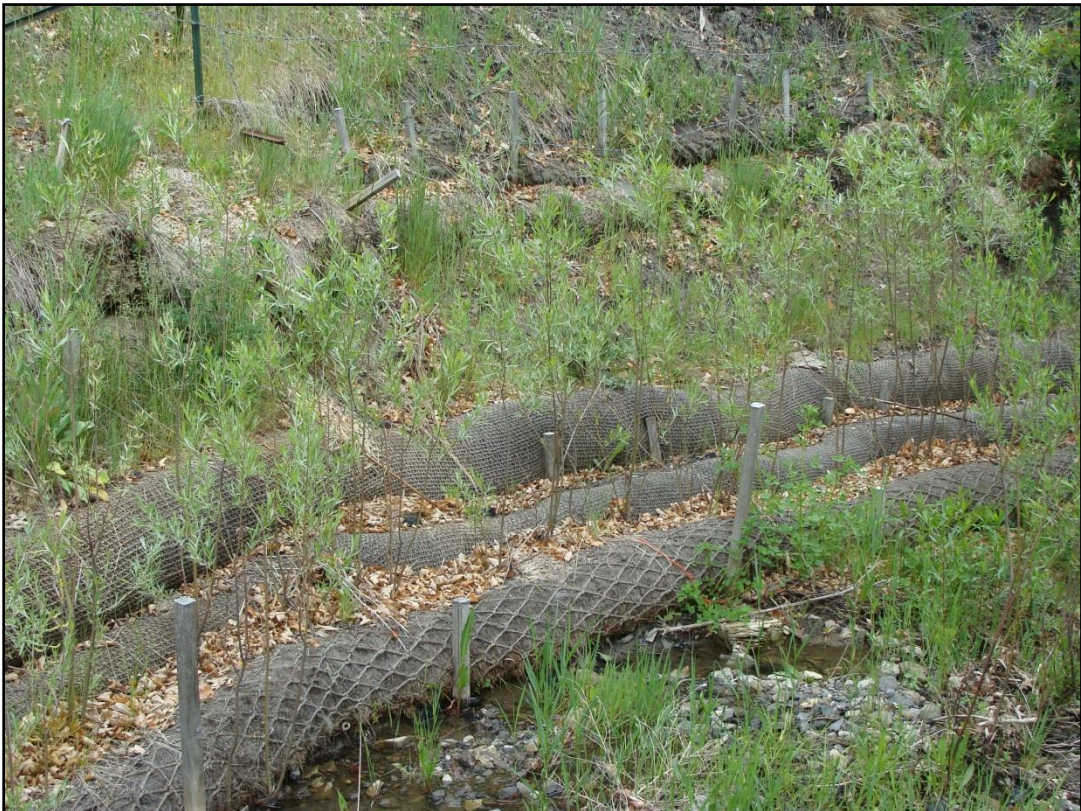
Willows at coir roll and coir blocks at the stream at the Sonchar Mine gob pile base, June 2009

To protect the reshaped gob pile from being undercut by the intermittent stream that runs along the base of the gob pile, coir (coconut husk fiber) rolls and coir blocks were installed along the stream edge, along with live willow (*Salix*) cuttings, for bank stabilization.

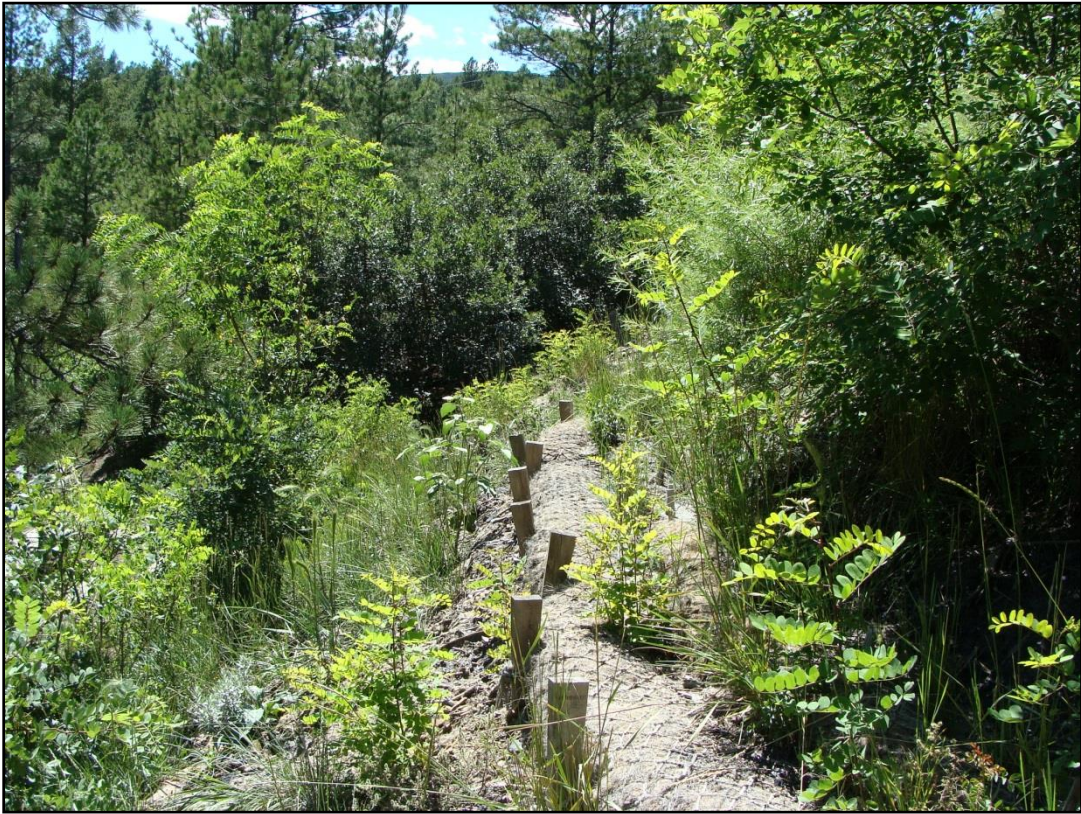
Hydroseeded slopes and plantings of native seedlings along coir rolls at one of the Franks No. 2 Mine steep gob piles reclaimed in-place, August 2010

Since space was limited at the Franks No. 2 Mine and local soil cover materials scarce, two of three gob piles at the site were reclaimed in place by incorporation of amendments (gypsum, lime, wood waste, and compost) into the gob materials. Straw bale and coir roll terraces with plantings of native seedlings were constructed on the gob steep slopes, branch packing installed in one deep gully, and the gob piles hydroseeded with native species. The third gob pile was buried in a pit excavated nearby and the gob material covered with salvaged topsoil, seedlings planted, and the surface seeding.

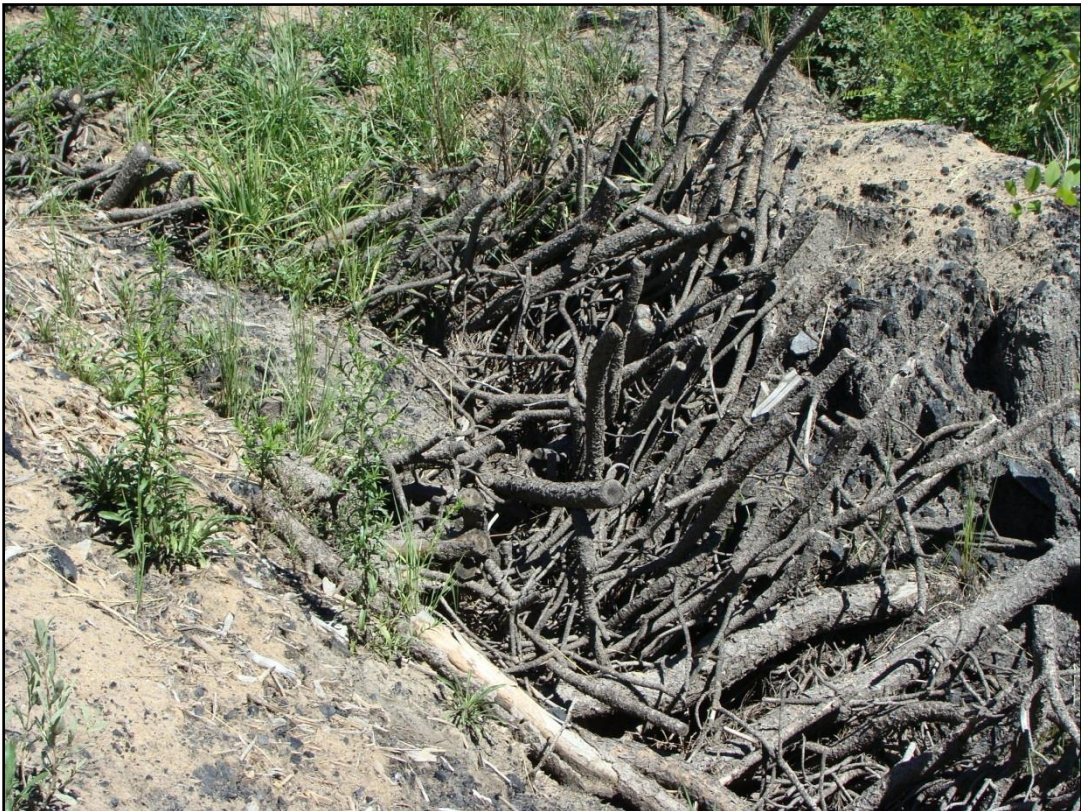
Branch packing of gully at a Franks No. 2 Mine gob pile, August 2010

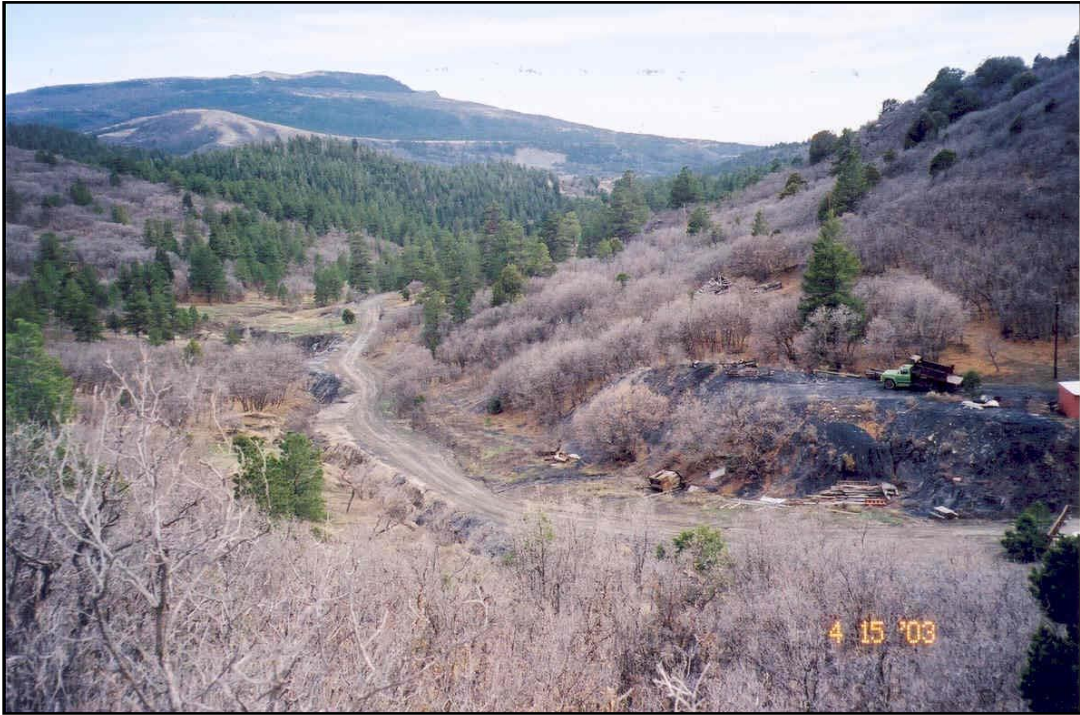
Gob, trash, and old mining equipment including vehicles had been dumped along and into an ephemeral stream adjacent to the Franks Nos. 1 and 2 Mines. The most severely impacted section of the stream adjacent to the Franks Mines was deeply incised with advancing headcuts and areas with piping erosion. Summer thunderstorms and spring runoff were undercutting the gully walls, collapsing them into the creek, and threatening to undermine a portion of the landowner's driveway.

Franks No. 1 Mine site with gob piles and degraded, incised stream channel, April 2003

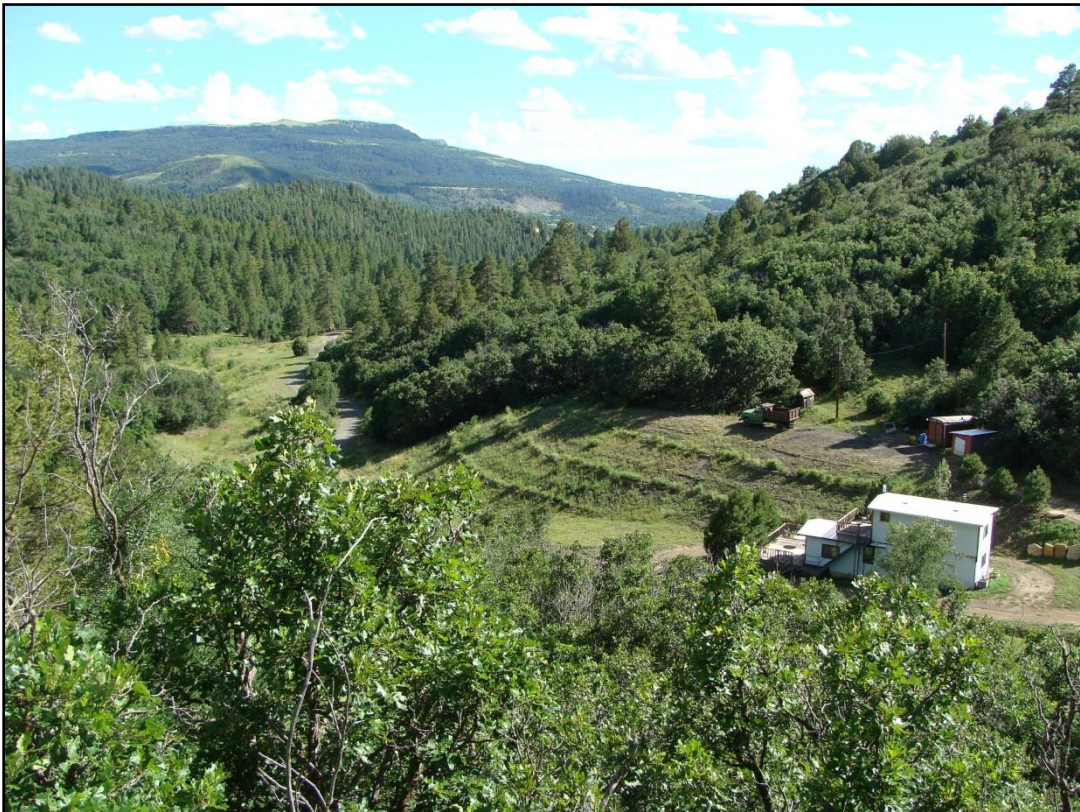
Franks No. 1 Mine site with re-graded gob piles and restored stream channel, August 2010

The AML Program designed relocation of a portion of the driveway, removal of trash and mining debris, and reconfiguration of 1,200 feet of the stream into a geomorphic, meandering pattern with maximum 2:1 side slopes. This portion of the stream drains 40 acres at the upper end and 60 acres at the lower end of the mine-impacted watershed. The Program used regional hydraulic geometry curves and the Rosgen Natural Channel Design method (Rosgen, 1996) to determine the new channel geometry. With the addition of 20 full meanders, stream sinuosity (the ratio of channel length to downvalley length) was increased from 1.07 to 1.22, lengthening the channel by 150 feet. Stream design parameters are listed in Table 1 below.

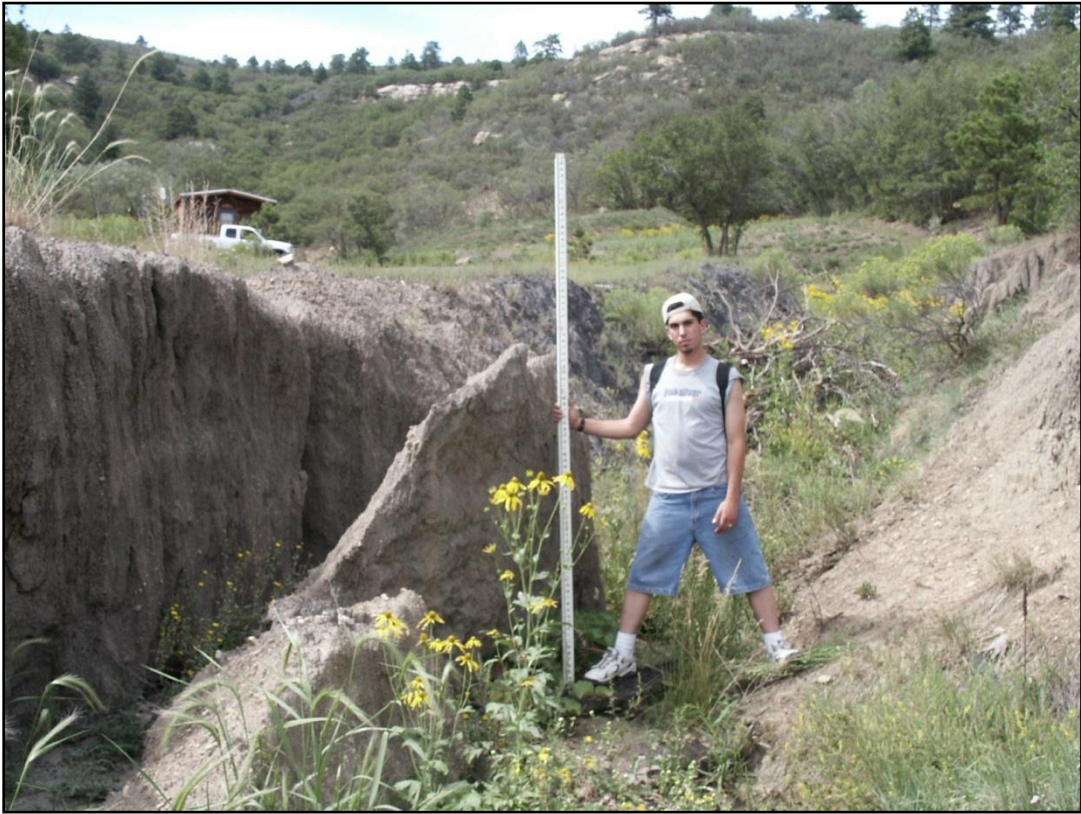
Incised stream channel at Franks No. 1 Mine, looking upstream, July 2002

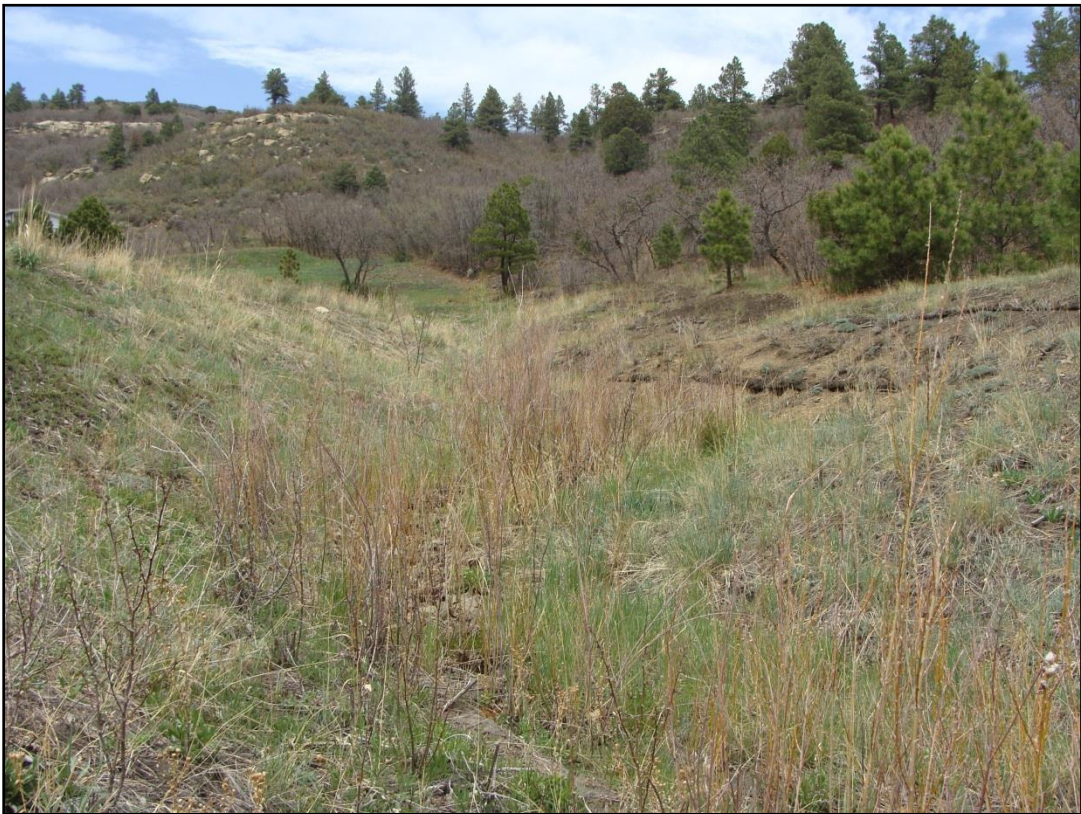
Restored stream channel with willows, May 2013

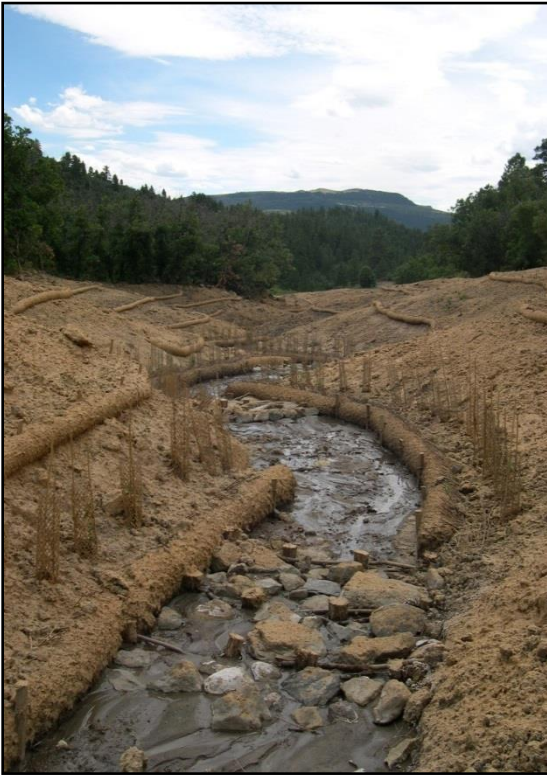
Newly installed wicker weir and coir rolls with native seedling plantings, 2005

Because the silty native soils at the relocated stream are erodible and completely free of rock, wicker weirs were constructed at the riffle points along the reconstructed channel to aid in stabilization of the channel base. Each wicker weir was constructed using three-foot long juniper posts driven in three rows across the channel bottom, flexible branches woven between the juniper posts, and four- to six-inch rock (see the photograph below). Coir rolls were placed along the outside of meanders to control lateral movement of the channel until growth of vegetation could establish more erosion-resistant banks. Seedlings were planted along the coir rolls.

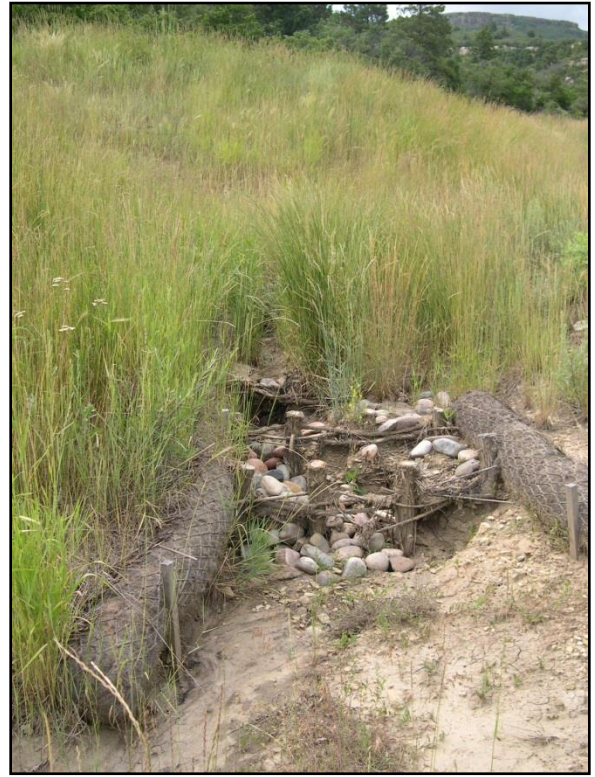
The installation of 12-inch diameter coir rolls, being taller than the 8-inch design bankfull depth, turned out to be a mistake. The rolls narrowed and deepened flows at the riffles during flow events, contributing to headcutting at many of the 40 wicker weirs installed. In a 2008 maintenance project many of the coir rolls were shortened, a few rolls removed, and additional rock added at riffle points.

Headcut at wicker weir, 2007

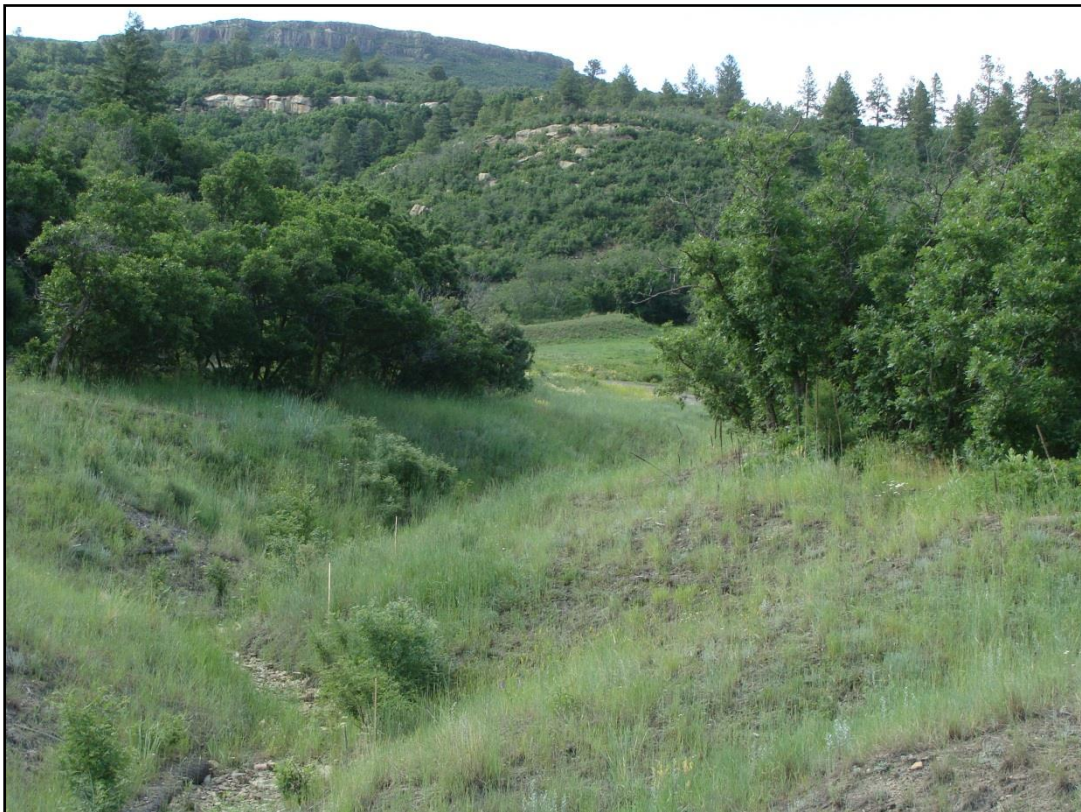
Restored stream, July 2009. Rock reinforcement added at two riffle points in fall 2008 is visible in lower left of photograph.

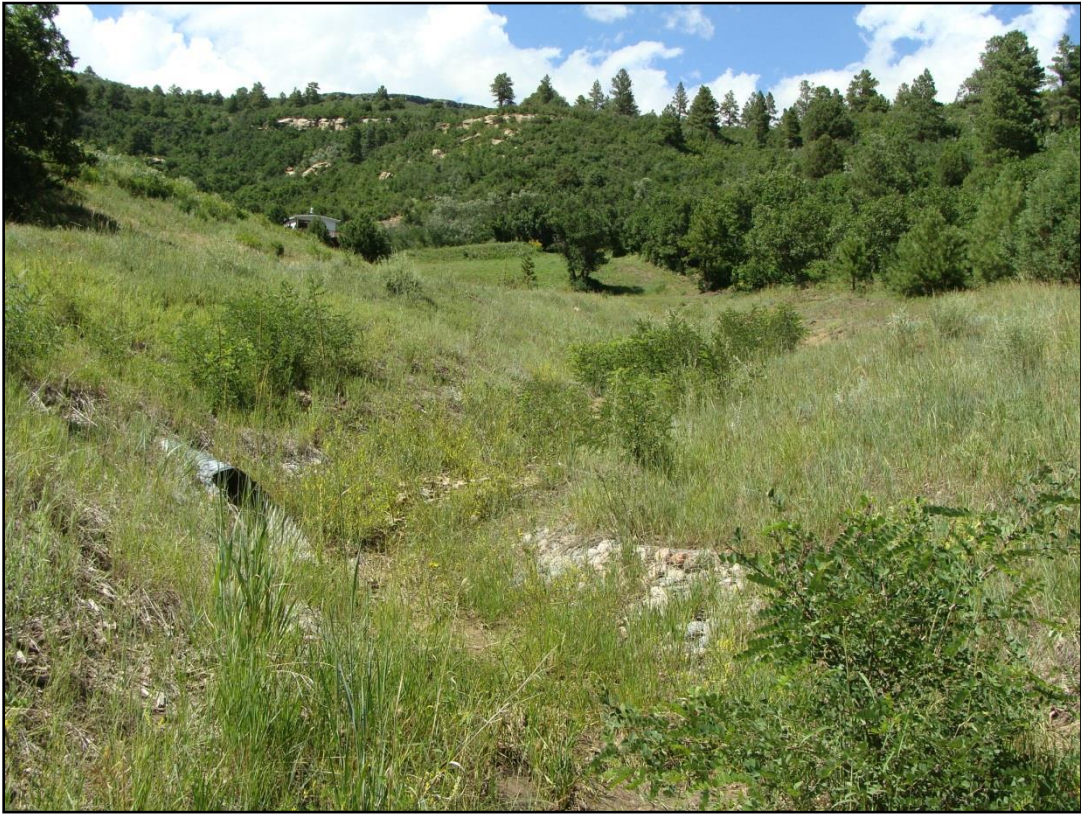
Vegetated gabion mattress at culvert outlet, August 2010

The gob dumped along the channel was buried under at least two feet of native soils during grading of the reconfigured channel. At the head of the relocated stream channel, a rock- and soil-filled gabion mattress rundown blanket was installed and seeded to prevent headcutting of the stream into the earthen pad on which the landowner's home is built. Another vegetated gabion mattress installation was placed at a culvert outlet into the channel. The stream banks and bottom were stabilized with live willow cuttings, rock lining at riffle points, planting of native seedlings, and hydroseeding with native seeds and a bonded fiber matrix. A sandstone bedrock outcropping controls grades at the lower end of the relocated stream.

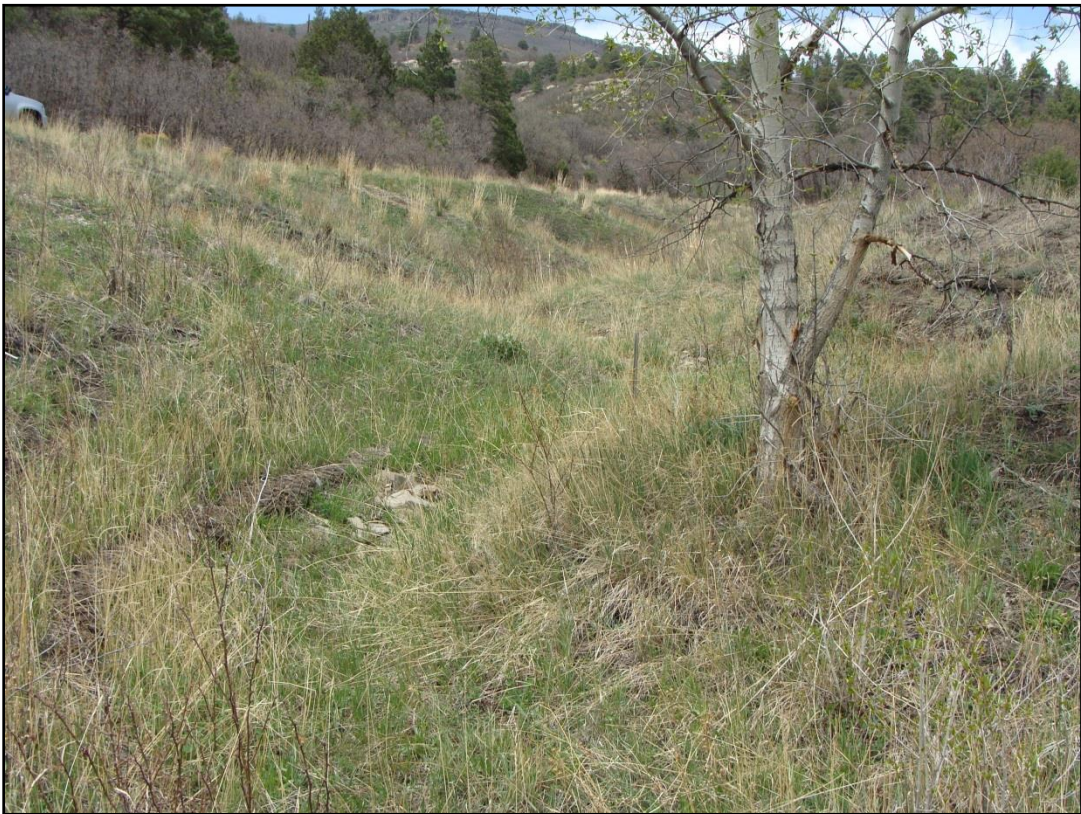
Near lower end of restored stream channel, looking upstream, May 2013

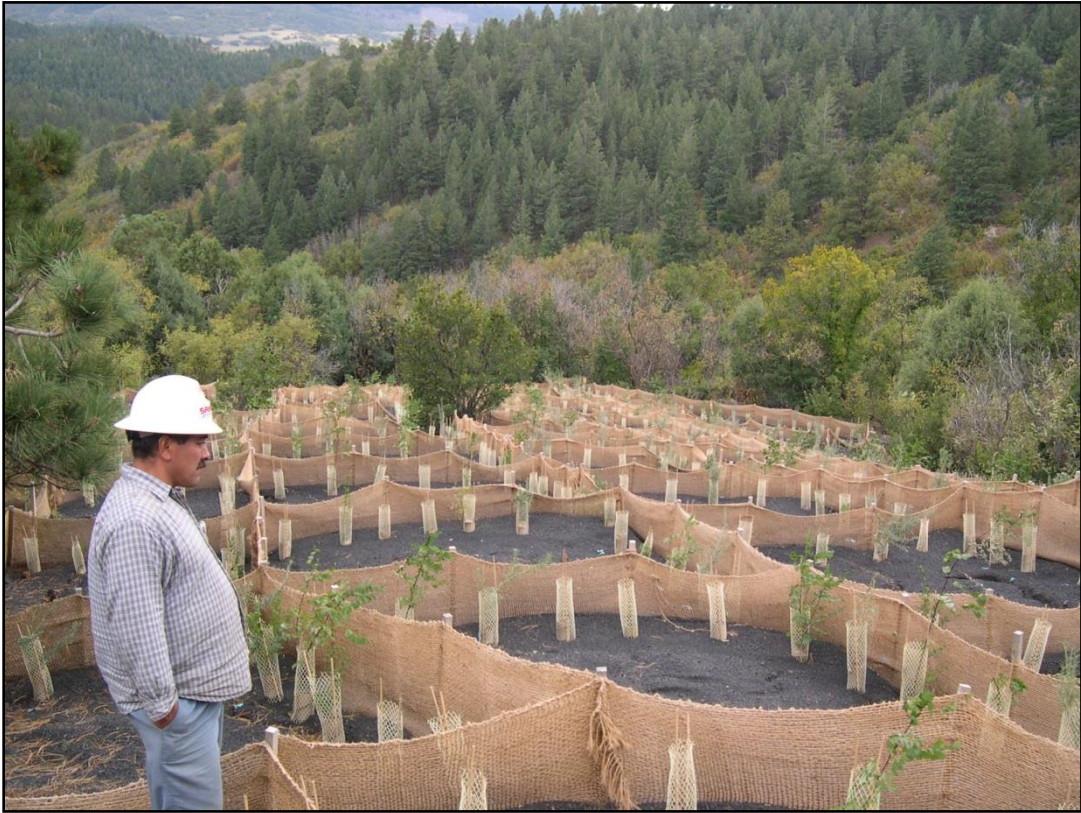
At the Sunset Mine, where another coal seam at higher elevations had been mined, the gob material was quite different from that at the Sonchar and Franks Mines. The Sunset Mine gob was very sandy (averaging 87% sand) and strongly acidic (with pH ranging from 3.2 to 4.4 and averaging 3.8, although low in pyritic sulfur). It supported almost no plant growth, largely because of the gob pile's low water-holding capacity and erodibility, its black color and south-facing exposure (leading to high surface soil temperatures), and its acidity. To alleviate these problems, shade fencing was installed and lime and compost incorporated into the gob, with additional lime mixed with the gob in individual seedling planting holes.

Sandy gob at the Sunset Mine, six months after seedling planting, October 2005. Cardboard tubes for seedling burial protection are visible inside the mesh tubes. Coir fencing runs north-south and east-west for seedling sun and wind protection.

The open-weave, biodegradable coir shade fencing provided temporary protection for the planted native seedlings from wind and south and west sun exposure. Seedlings were planted six inches below the surface, both to place their roots below the extremely hot, black gob surface and at a depth where they could more easily access deeper soil moisture (Martin, 1976). Cardboard tubes protected the young stems from burial by the sand. By the time the tubes deteriorated, the seedlings were large enough to tolerate moderate stem burial. In this very droughty material, the seedlings were watered once at the time of planting and, using hydrogel time-release watering packages, for the first growing season. Long-term revegetation success at this challenging site has been acceptable, although some plant die back and mortality in recent drier years has been noticed.

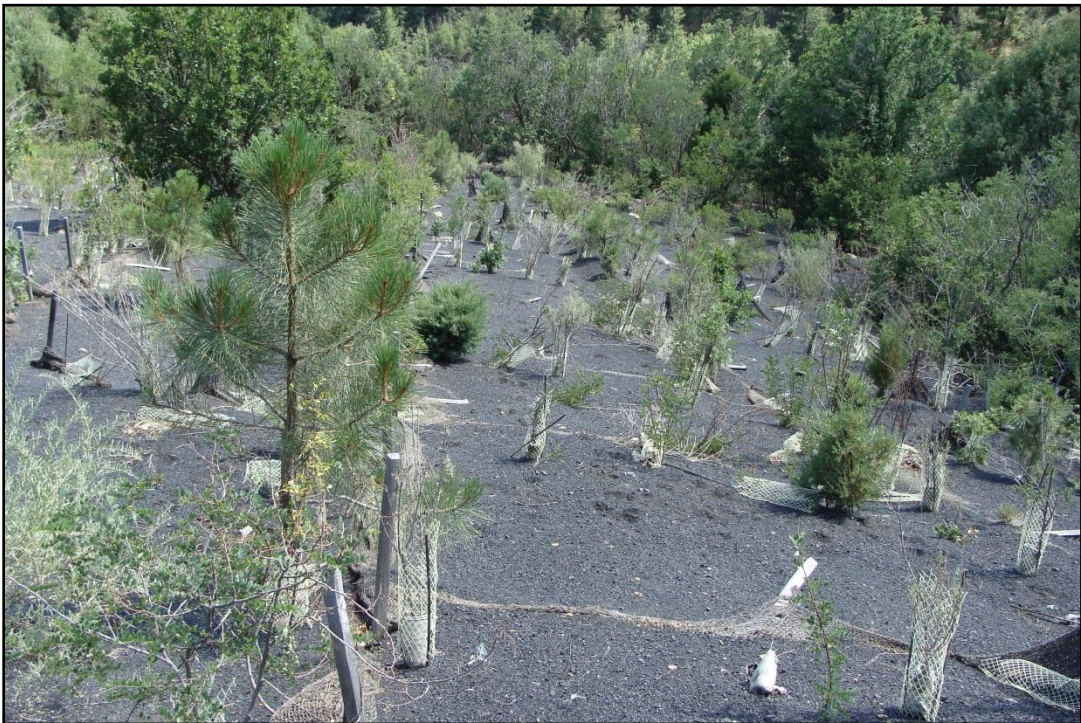
Sunset Mine gob pile, July 2011. Some cardboard tubes at plantings are still visible.
