The 2017 Excellence in Reclamation Award is presented to Rangeland Hands, Inc., and its subcontractor, Riverbend Engineering, LLC, for their work in Madrid on the Low Impact Stormwater Project, where they designed and applied state-of-the-art, innovative reclamation techniques to mitigate historic mining-related impacts to people and the environment.

2017 EXCELLENCE IN RECLAMATION AWARD
IS PRESENTED TO:

For the design and application of state-of-the-art, innovative
reclamation techniques in the Madrid Low Impact Stormwater Project
that mitigated historic mining-related impacts to people and the
environment in Madrid, New Mexico

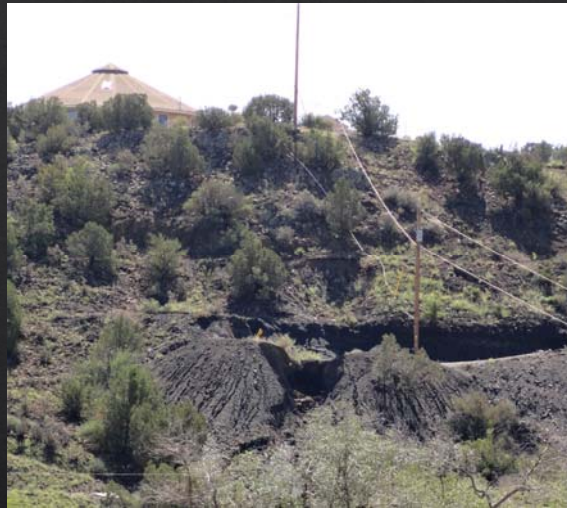
Deeply eroded gob pile above Museum and Icehouse Road. Precast barriers were placed along the driveway above the gob pile to divert runoff to the upper drop inlet

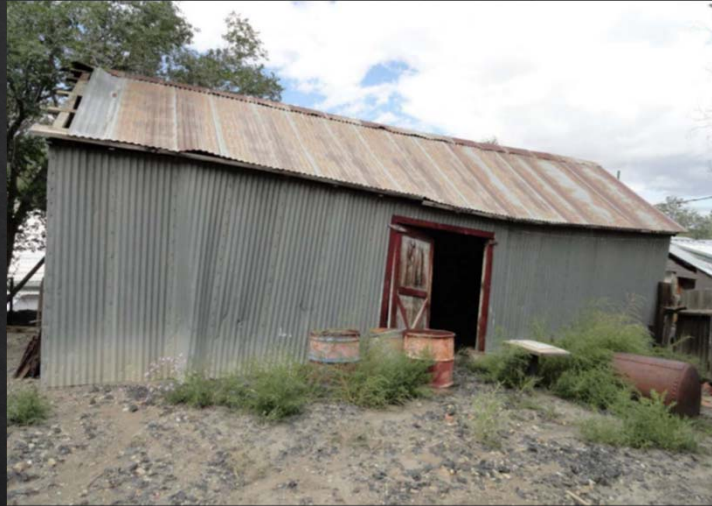
Coal debris damage to historical Museum building below eroded gob pile

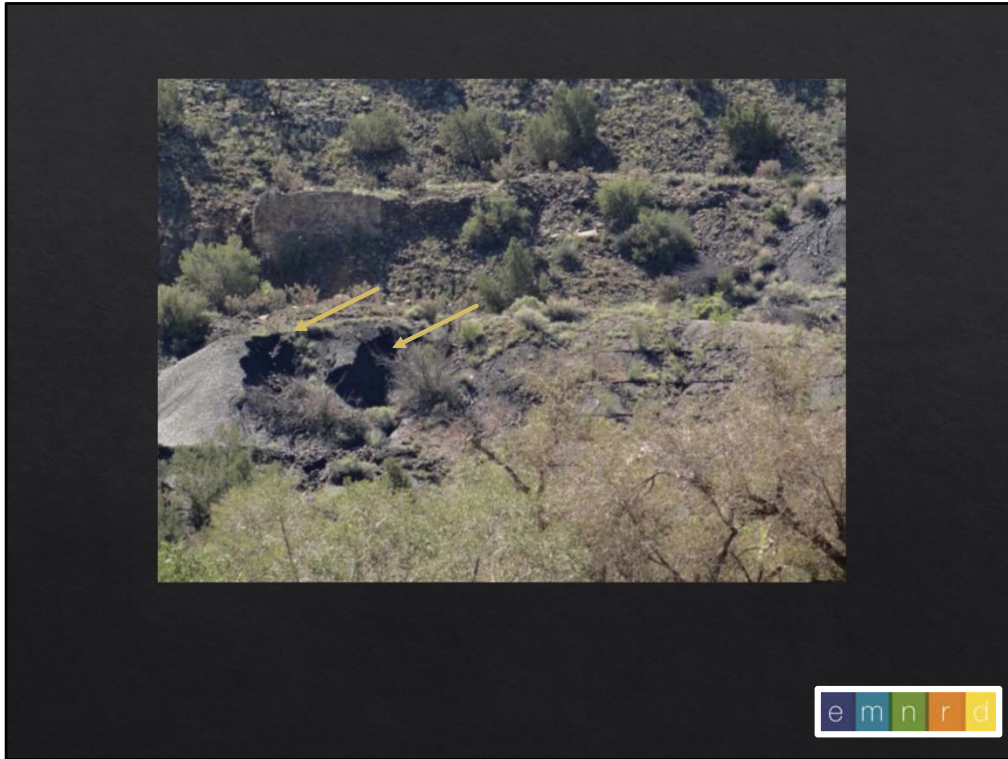
The arrows on this slide indicate the newly blown-out gob pile above the Museum.

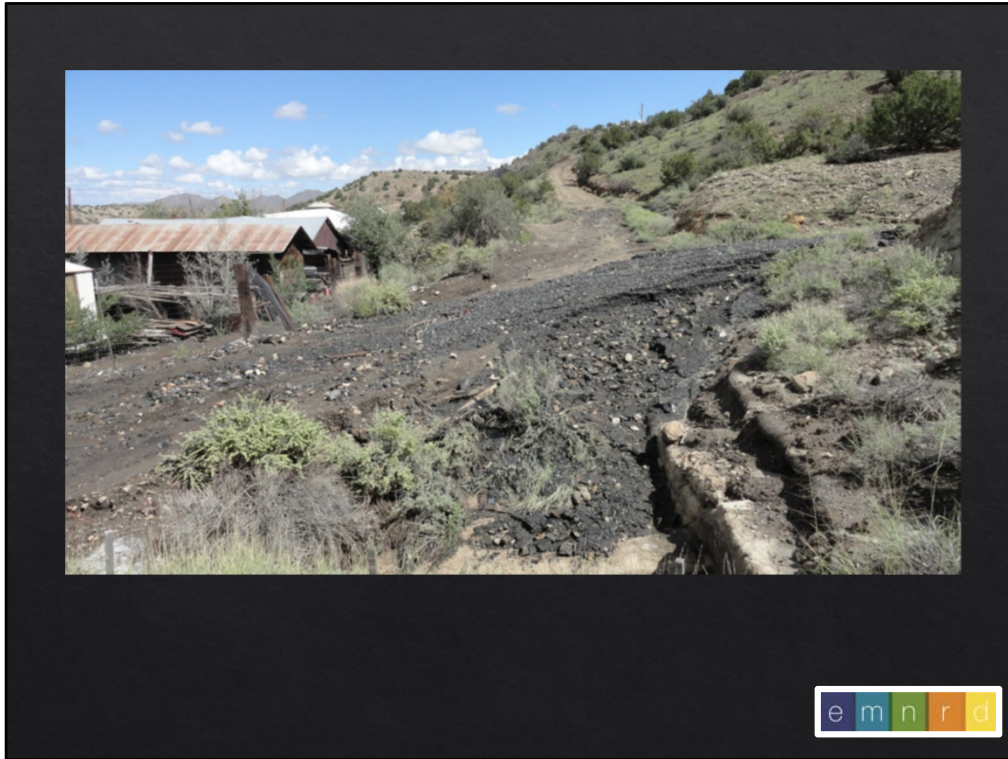
This shows the debris flow from a gob blowout across the driveway and onto Museum property.

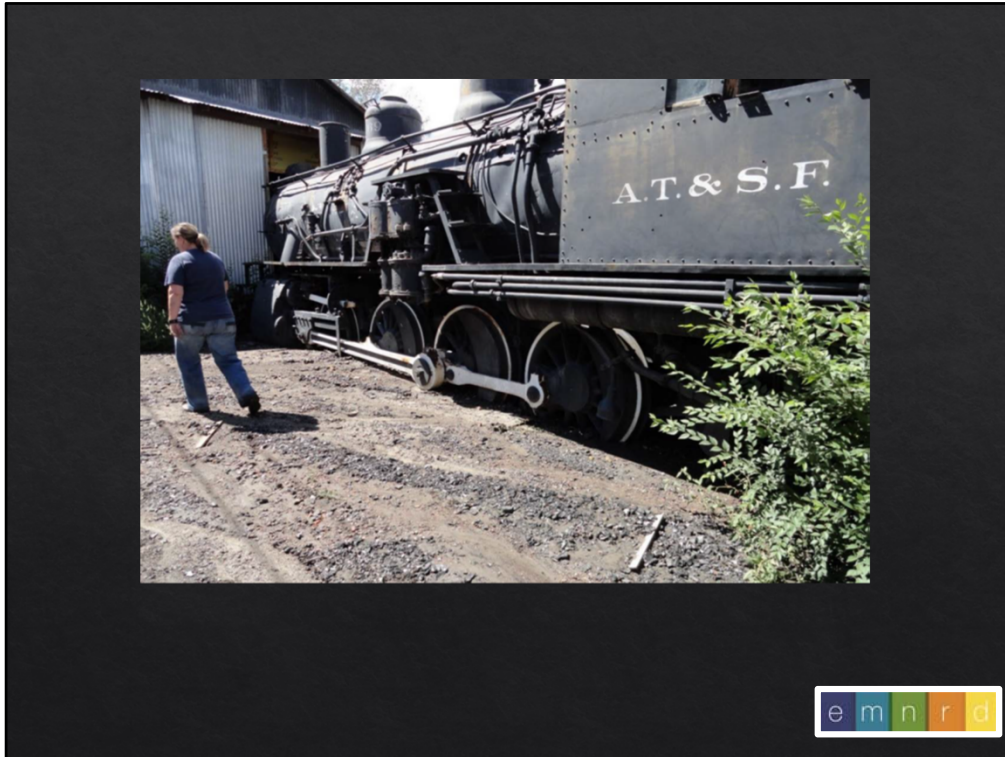
Here you can see the gob blowout debris build-up against a steam locomotive at the Museum.

Within two weeks, NMDOT mobilized to clear a clogged culvert and drop inlet along State Road 14 near the area of the blowout, and Rangeland began construction of immediate measures to protect public health, safety, and property. Measures included installing temporary protective Jersey barriers below the blown-out gob pile and above the Museum; installing other Jersey barriers at the head of a gob pile being deeply eroded by drainage off a nearby driveway; grading and installation of base course at driveways eroded by runoff from the gob piles; and rock lining of roadside ditches along portions of the driveways most impacted.

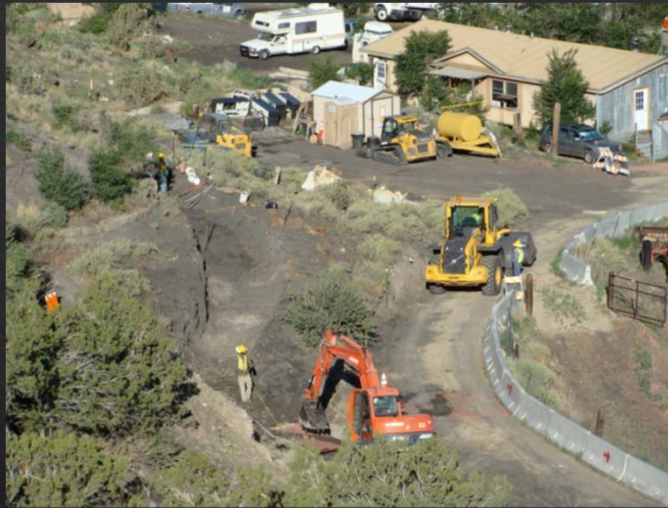
Working in tight quarters to construct a rock bypass channel
July 2014

AML and Rangeland then planned and executed more permanent measures. In June 2014, Rangeland remobilized equipment and crews to the site to construct rock channels on the hillside to divert stormwater around or to carry it safely across the gob piles above the Museum. An adit that had reopened in the area was backfilled. And, additional compost and mulch applications, and planting and seeding of native species further stabilized the gob piles.

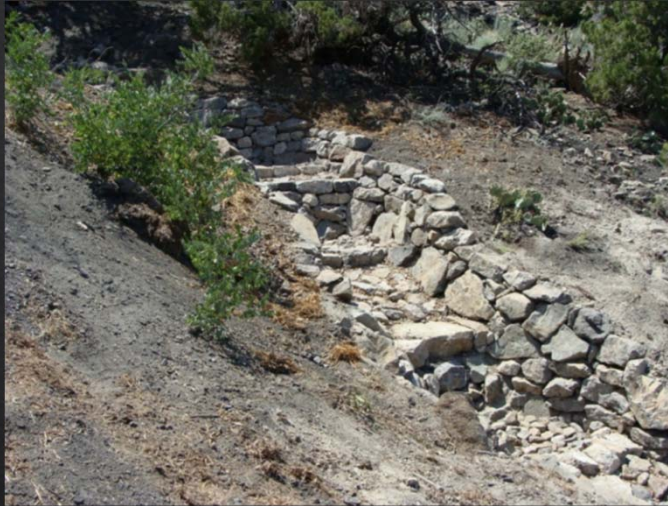
Hand-built step-pool rock channel at edge of larger gob pile
July 2014

Rangeland constructed two types of innovative low rock barriers on the larger of two gob piles, both of which slow and infiltrate precipitation to aid in vegetation establishment and growth while armoring the surface against erosion. The low rock barriers and rock channels were designed in place and installed by experienced operators and crews.

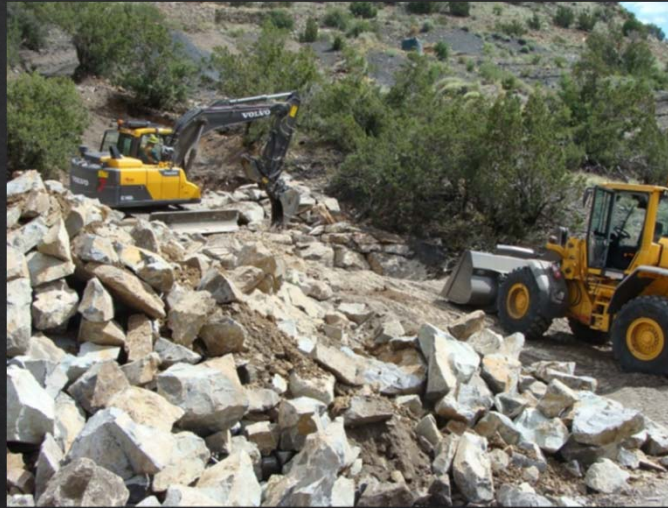
Constructing a machine-built, step-pool rock bypass channel around blown-out gob pile
July 2014

Steeper rock channels were constructed as step-pool structures, which dissipate a portion of the water's kinetic energy at each drop.

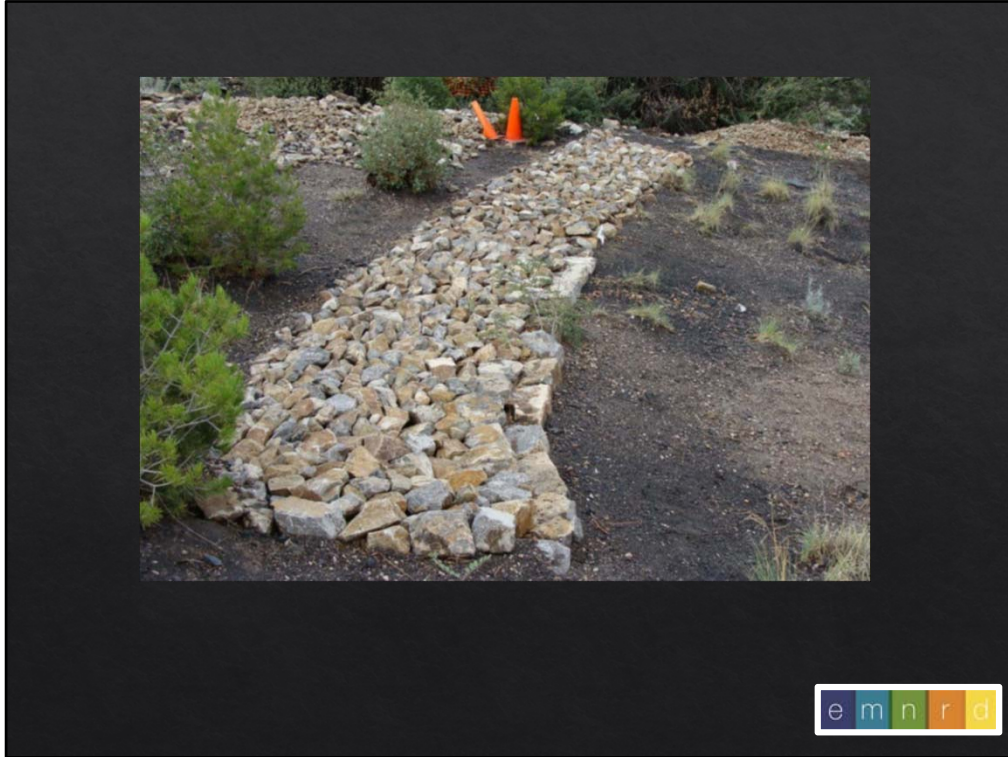
This is a rock media luna on the larger gob pile to collect sheet flow, slow and infiltrate it, and direct it toward a rock mulch rundown below

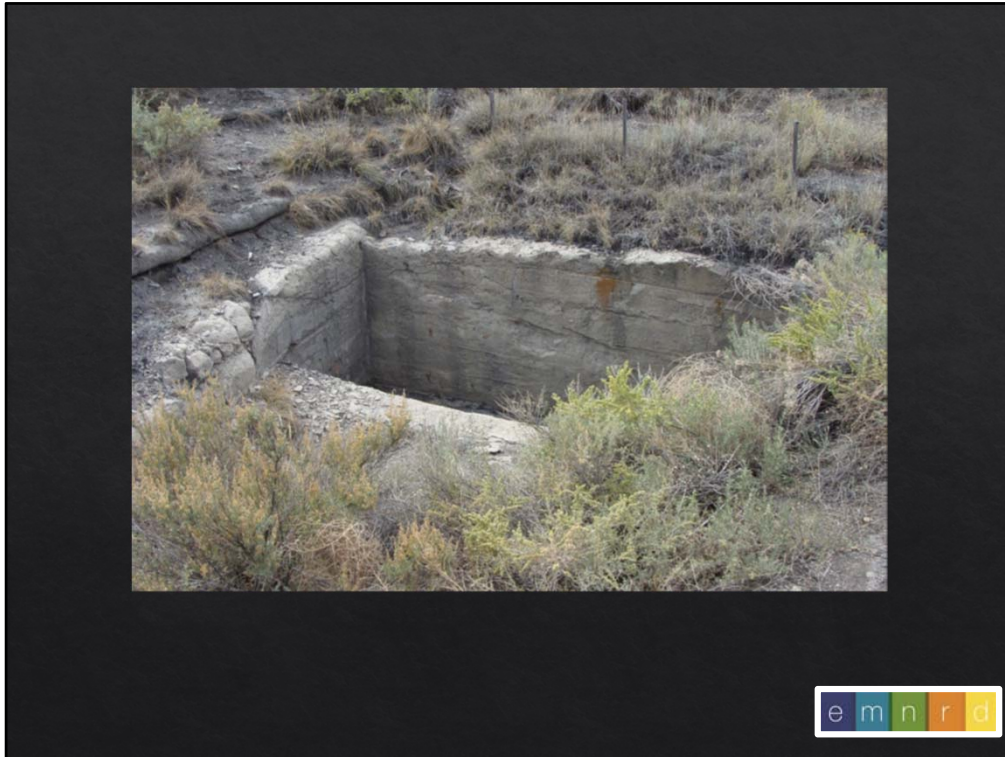
By mid-September, the work to stabilize the hillslope above the Museum was complete and attention shifted to improving stormwater conveyance from the hillslope to the arroyo. A dilapidated mining-era drop inlet collected stormflows from the hillside and gob piles and carried them underneath a couple of the Museum buildings and the Mine Shaft Tavern in a derelict four-foot square concrete box culvert to a more recently constructed NMDOT drop inlet in front of the Tavern. Examination of the box culvert indicated that it was severely clogged with mining debris.

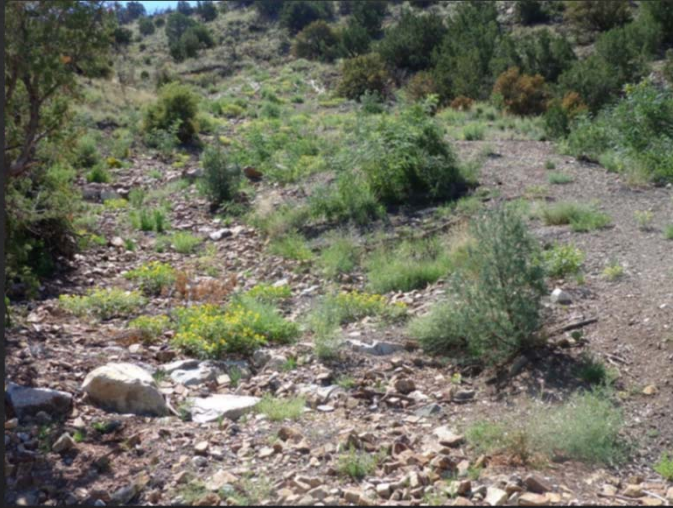
August 2015

One year after construction, vegetation had taken hold at a rock diversion channel on the left and smaller reclaimed gob pile on right.

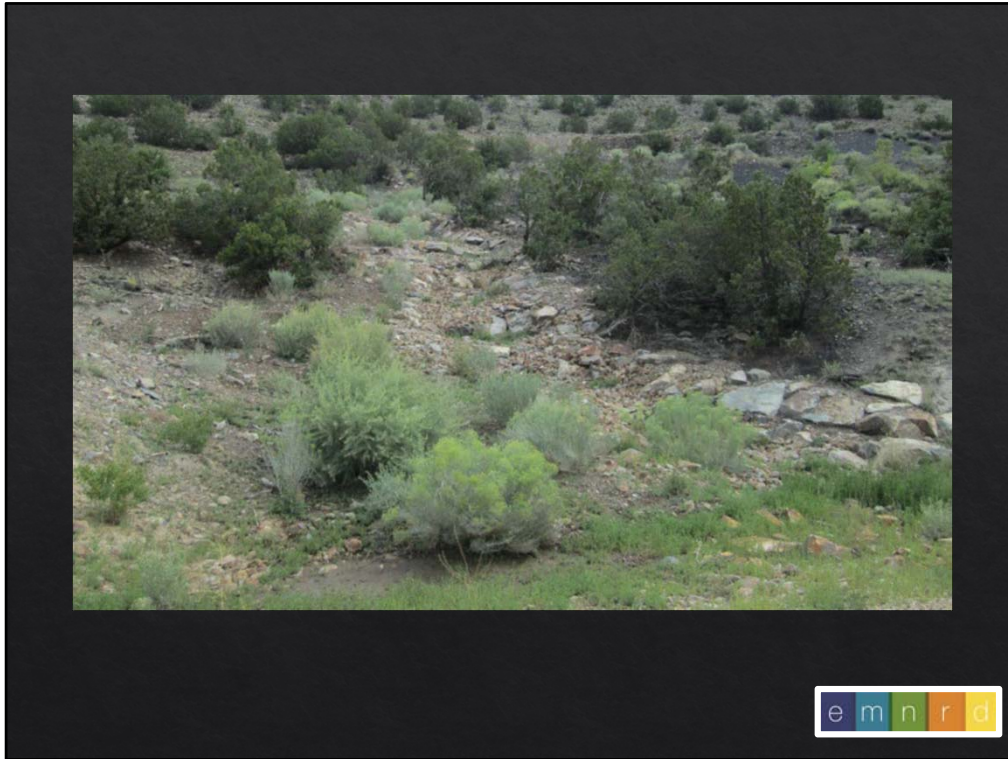
The completed step-pool rock bypass channel in August 2016. Note planted and seeded vegetation in and around the channel. The large light colored rock was covered with smaller tan rock to better blend channels into the surroundings.

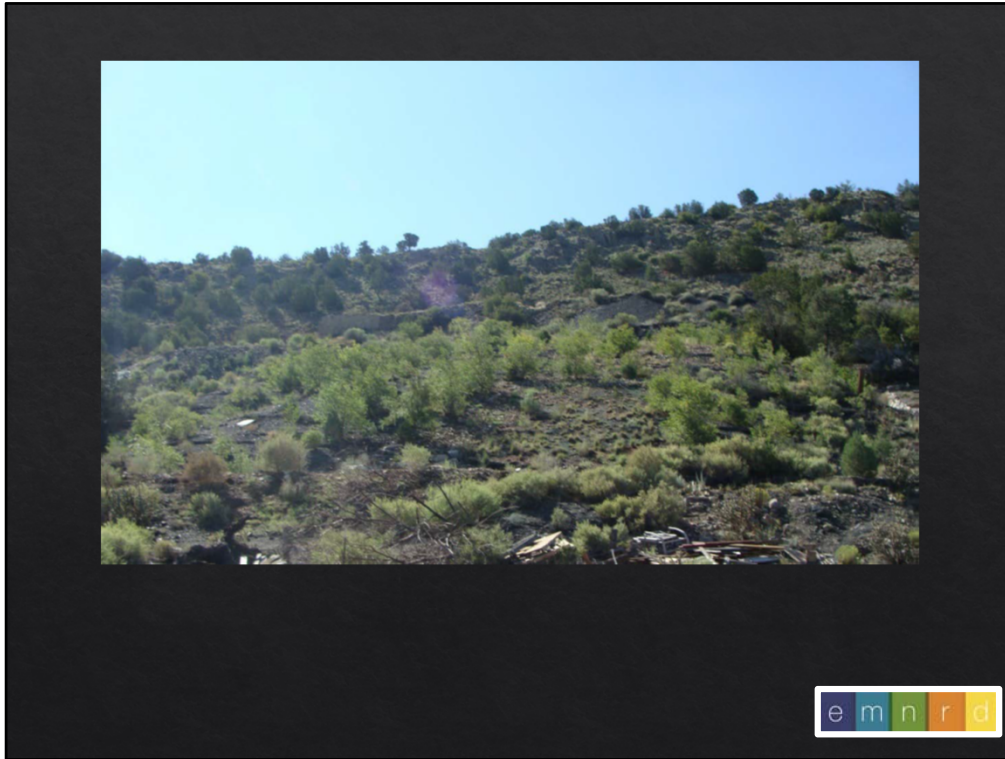
This shows a view of the larger reclaimed gob pile in August 2016, which was initially reshaped and reclaimed in 1999 and additionally stabilized in 2014.
