## Lake Valley Mine Safeguard Project - Phase I

The Lake Valley Mine Safeguard Project - Phase I area is located in and around the ghost town of Lake Valley, seventeen miles south of the town of Hillsboro, in Sierra County, New Mexico. The project area is on private and public land.

The project site consisted of 42 shafts, 26 pits and 12 adits, all of which were dangerous to the public at large.

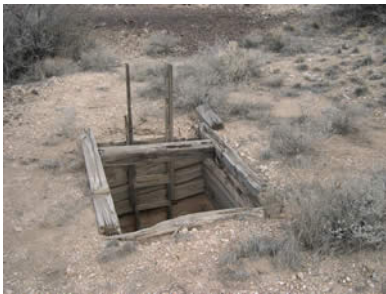
Bat Cupola at 829-23

A very dangerous mine shaft going down a depth of 61 ft. Bats were found to be using this feature.

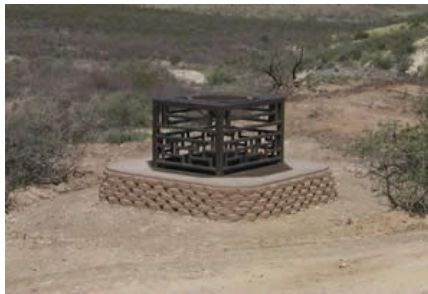
Bat Cupola after construction. The color of the concrete was chosen to blend in with the surrounding terrain.

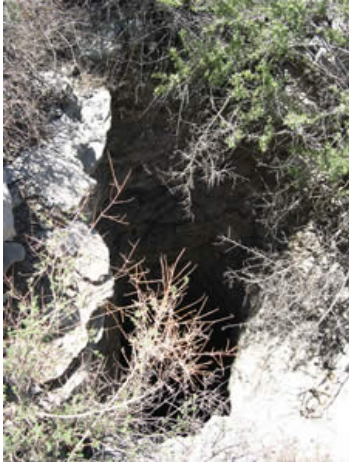
Bat Cupola at 835-14

A very dangerous mine shaft going down a depth of 22 ft before connecting with other mine workings. Bats were found to be using this feature.

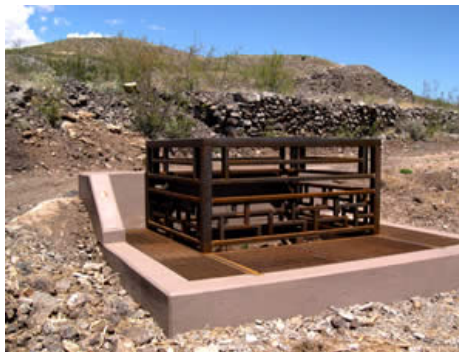
The slope of the land proved to be a challenge in developing a safeguarding plan for this feature. The bat cupola is built to allow bats to come and go while keeping curious humans out.

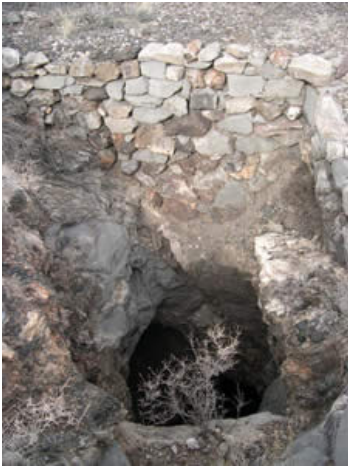
Airflow Closure at 832-04

A very dangerous mine shaft going down a depth of 26 ft before connecting with other mine workings. Bat habitat underground was preserved by the airflow this opening provided.

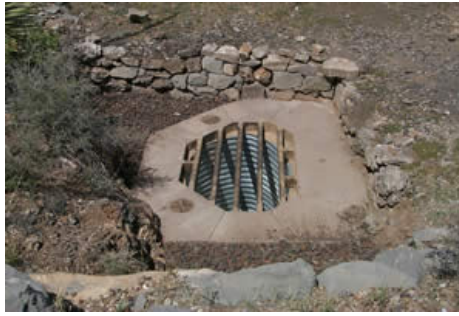
There were three objectives for the closure of this mine feature:

1. Provide human safety.
2. Continue the airflow to and from the feature to enhance bat habitat.
3. Preserve the historic aspects of the retaining wall as feasible.

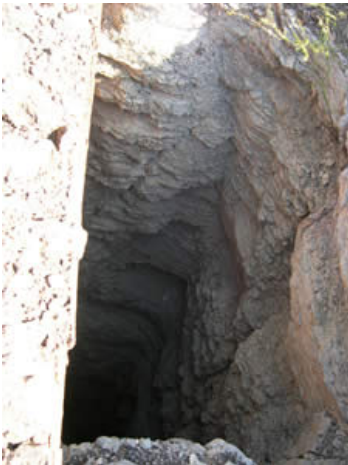
Airflow Closure at 834-07

A very dangerous mine shaft going down a depth of 38 ft before connecting with other mine workings. Bat habitat underground was preserved by the airflow this opening provided.

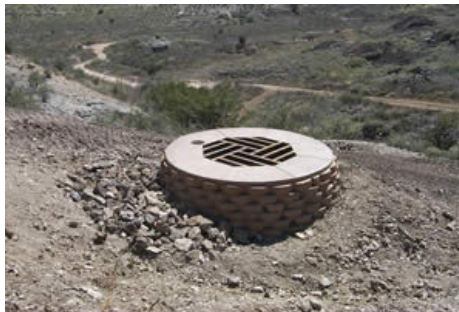
Airflow closure preserving bat habitat.
