## Granite Gap Mine Safeguard Project

The Granite Gap Mine Safeguard Project is located approximately 12 miles south of Road Forks and 28 miles southwest of Lordsburg in Hidalgo County, New Mexico. The project area lies on private and federal land in portions of Sections 34 and 35 of Township 25 South, Range 21 West and Sections 3 and 4 of Township 26 South, Range 21 West, New Mexico Principal Meridian.

The project basically involved the following work:

- Backfilling of 19 mine features using mine waste and other nearby material.
- Construction of 18 structures to protect wildlife while safeguarding mine features.
- Seeding of all areas disturbed by construction.

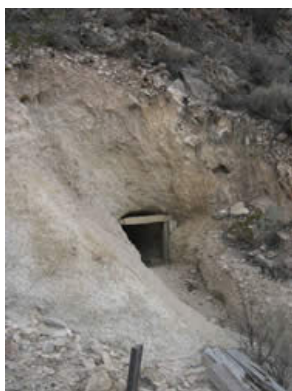
**BEFORE**

A mine adit leading to the inner workings in the mountain.

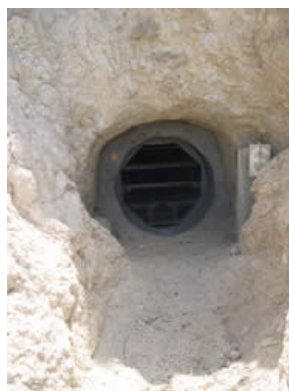
**AFTER**

The bat gate was built to allow bats to come and go while keeping curious humans out.

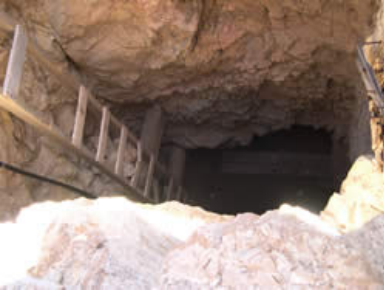
AML 43-7

Mine shaft with rickety ladder. Water is sometimes found at the bottom.

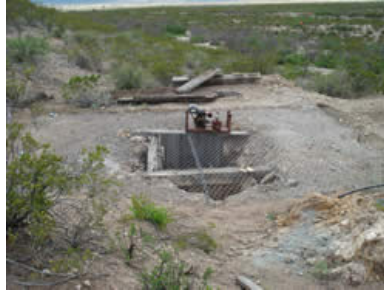
High tensile steel mesh now cover the shaft opening. Potential access to water is preserved.

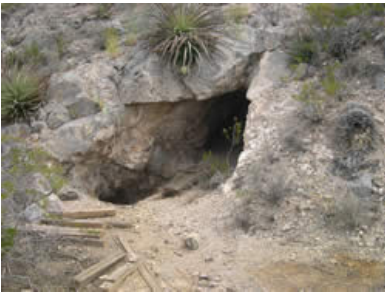
AML 44-5

An adit with an open stope near the entrance. The stope was not used by bats and was covered with high tensile steel mesh. The bat gate was built just inside the view of this photo angle.

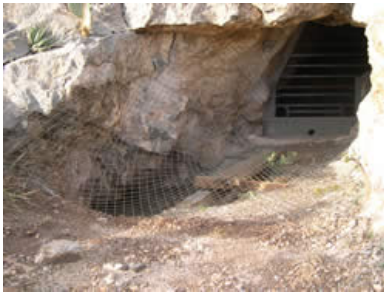
This bat gate was built to allow bats to come and go while keeping curious humans out. The stope at the front entrance, which is not used by bats, was covered with high-tensile steel mesh.

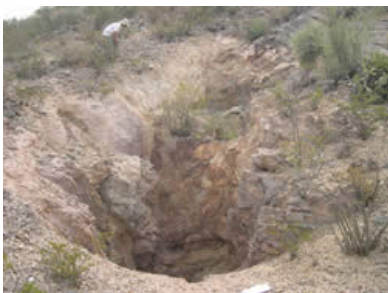
AML 44-11

A shaft in a location with no vehicular access.

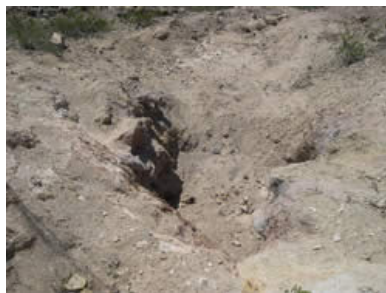
The shaft was backfilled by hand. A slight depression was left for historical purposes.

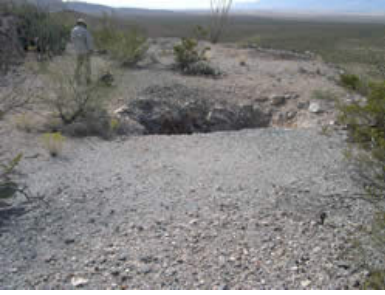
AML 47-1

This shaft went down more than 300 feet. Bats were not found but it was home to barn owls.

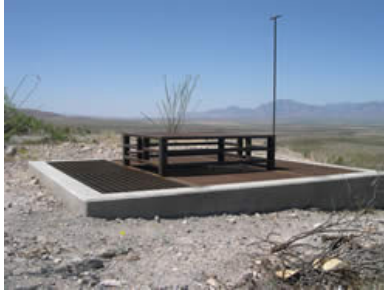
This cupola closure allows for use by owls and possibly bats. The lack of backfill material nearby made this a sensible option.

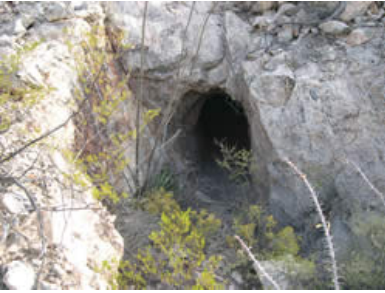
AML 49-8

A mine adit leading to the inner workings of the mountain.

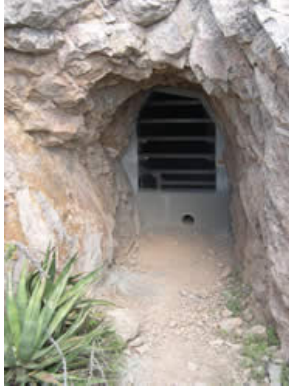
A bat gate built at the adit entrance.

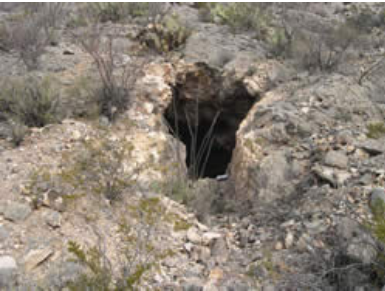
AML 49-13

Adit that leads into the interior workings of the mountain. AML had to remove a colony of africanized bees at the entrance before starting construction.

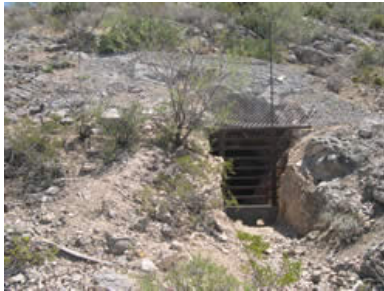
Bat gate constructed at the entrance to the adit. High tensile steel mesh was installed above the gate along with a raptor perch.

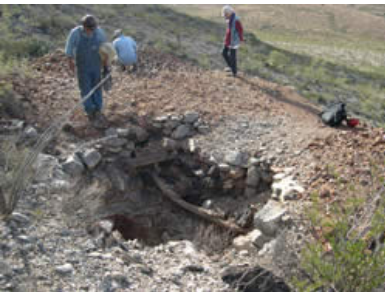
AML 49-18

Shaft entrance that hosted bats and barn owls.

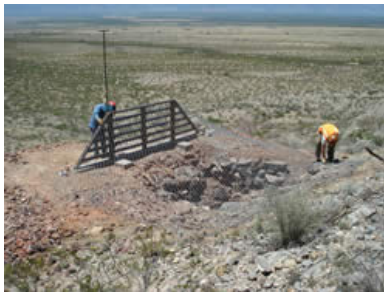
A unique bat gate constructed at the entrance to the shaft. High tensile steel mesh was attached to the gate and covered the shaft. Barn owls continue to use the gate for entry.

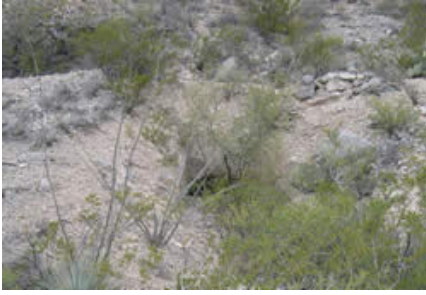
Adit with bat use

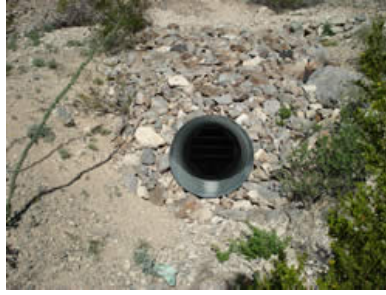
A culvert with a bat gate has been constructed at the adit entrance.
